Lake Bertha

Impervious Surface Coverage by Parcel

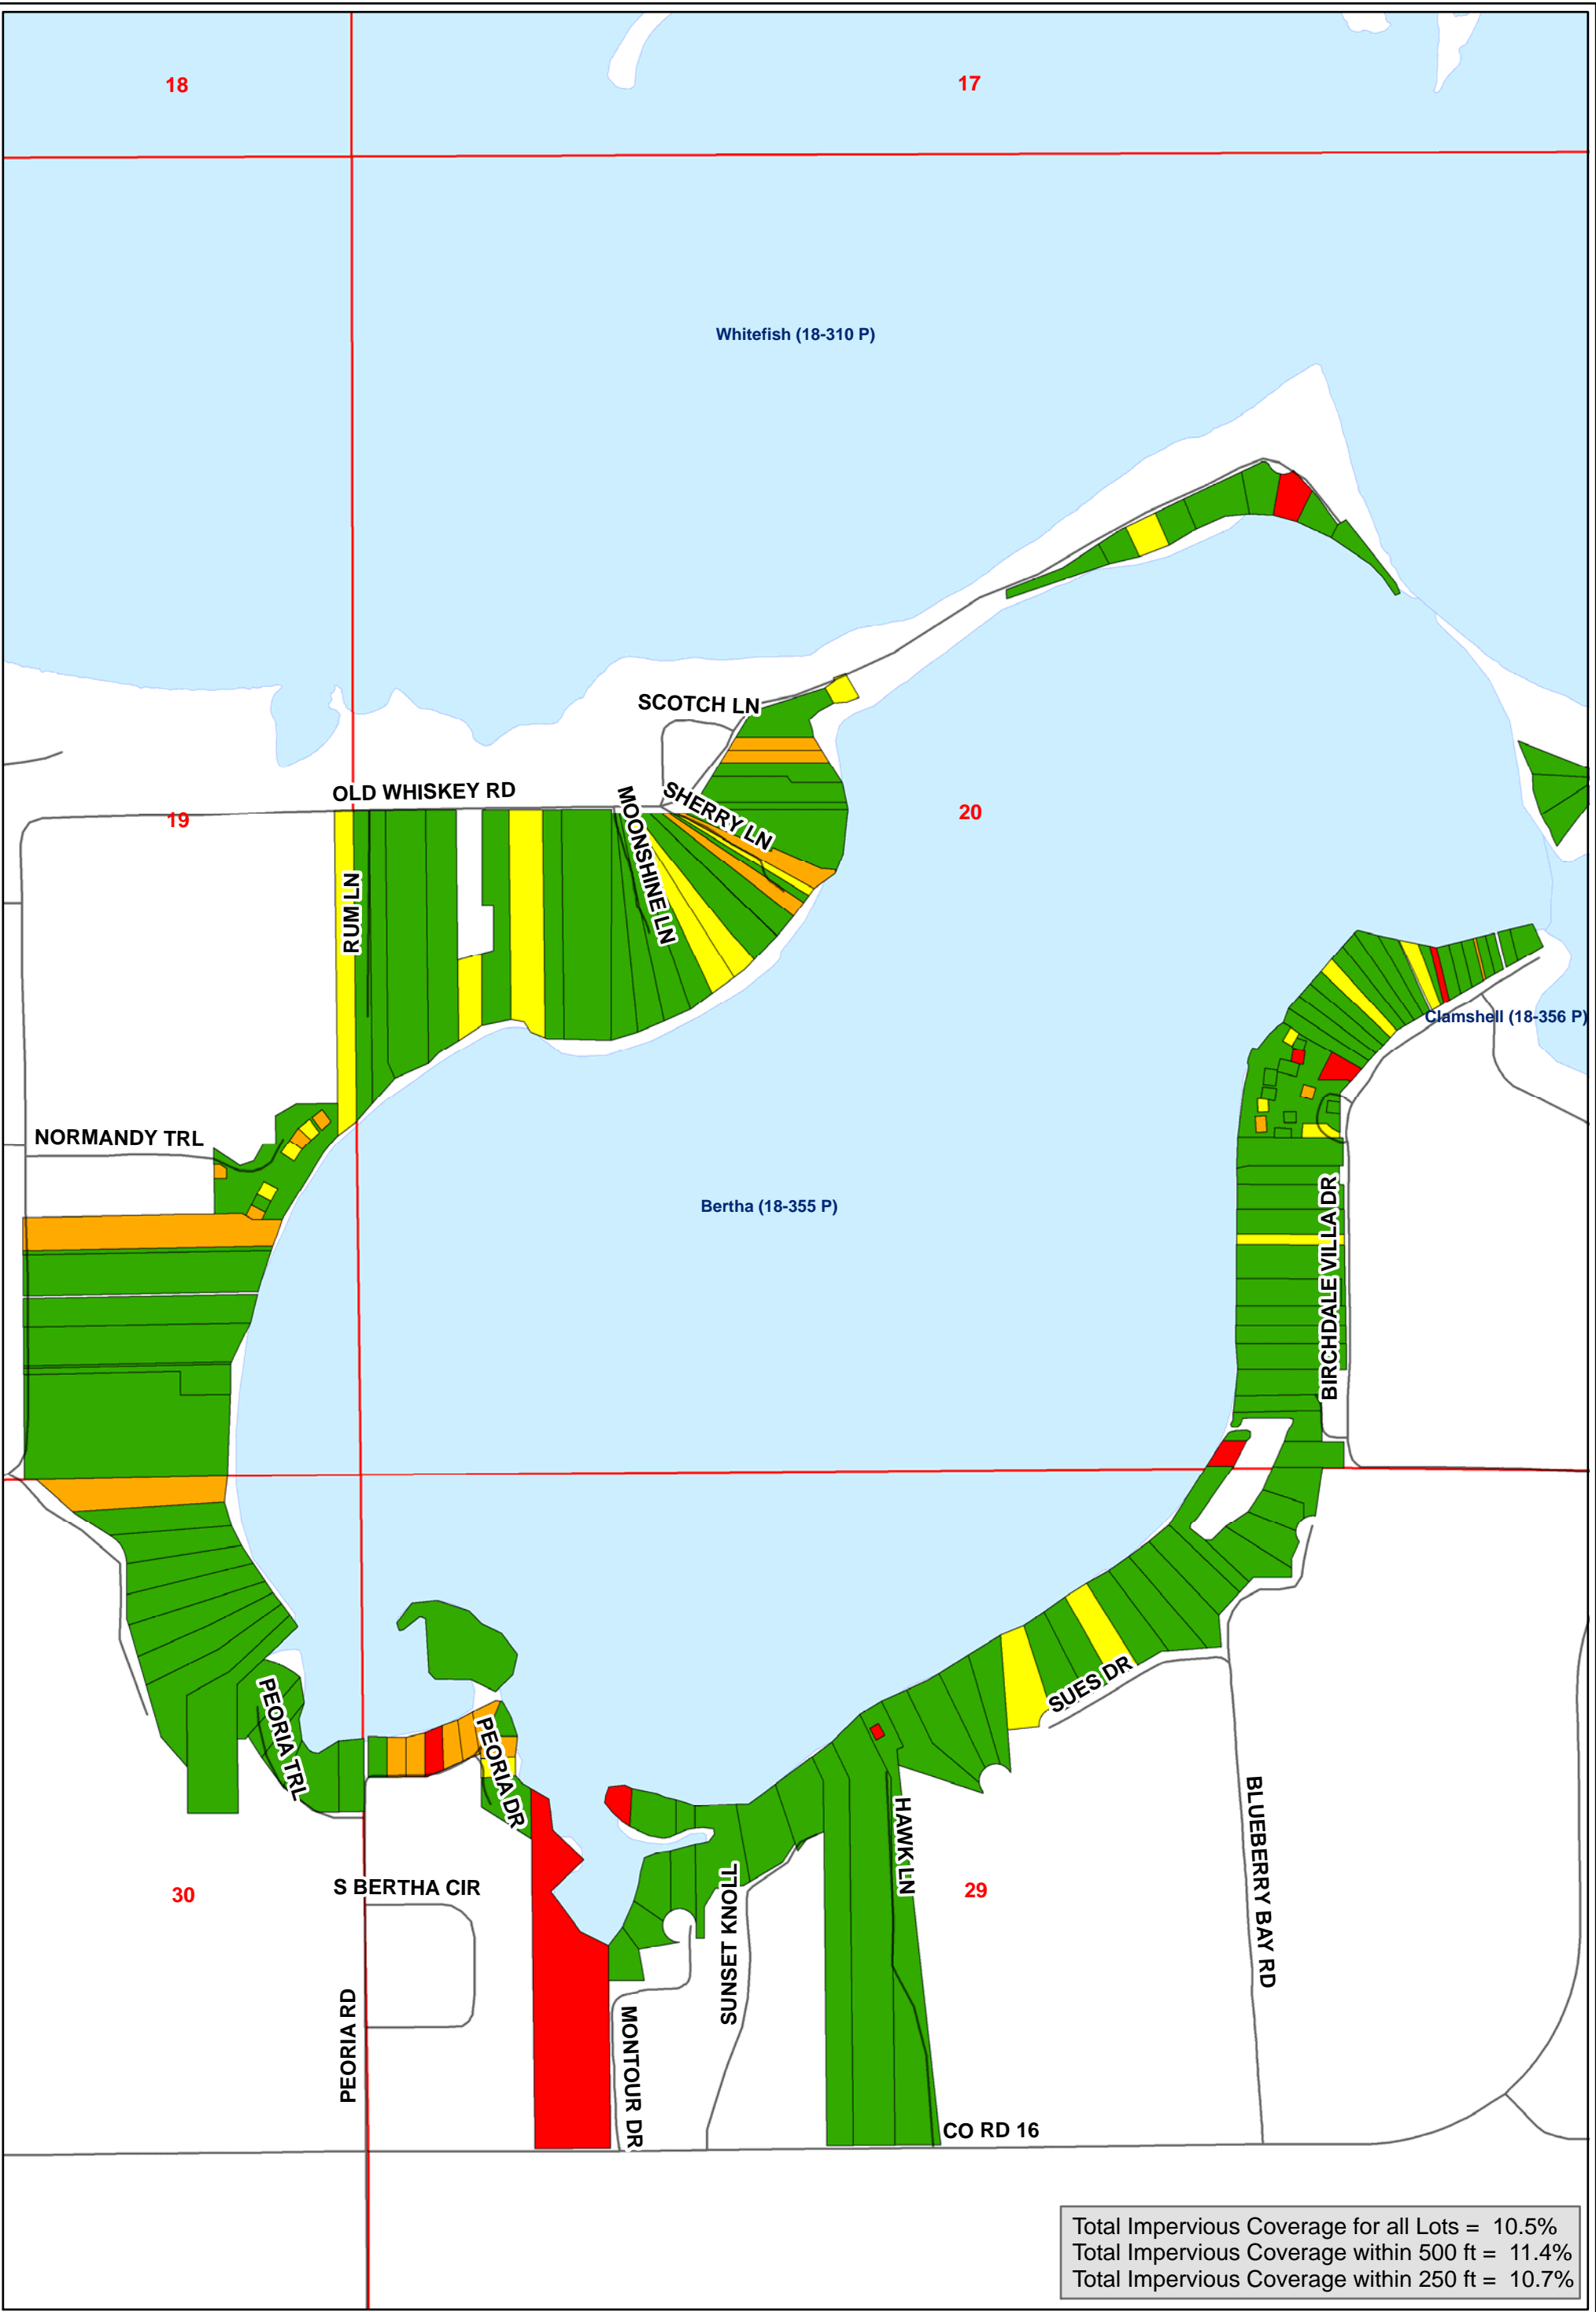
Total Impervious Coverage for all Lots = 10.5%
 Total Impervious Coverage within 500 ft = 11.4%
 Total Impervious Coverage within 250 ft = 10.7%

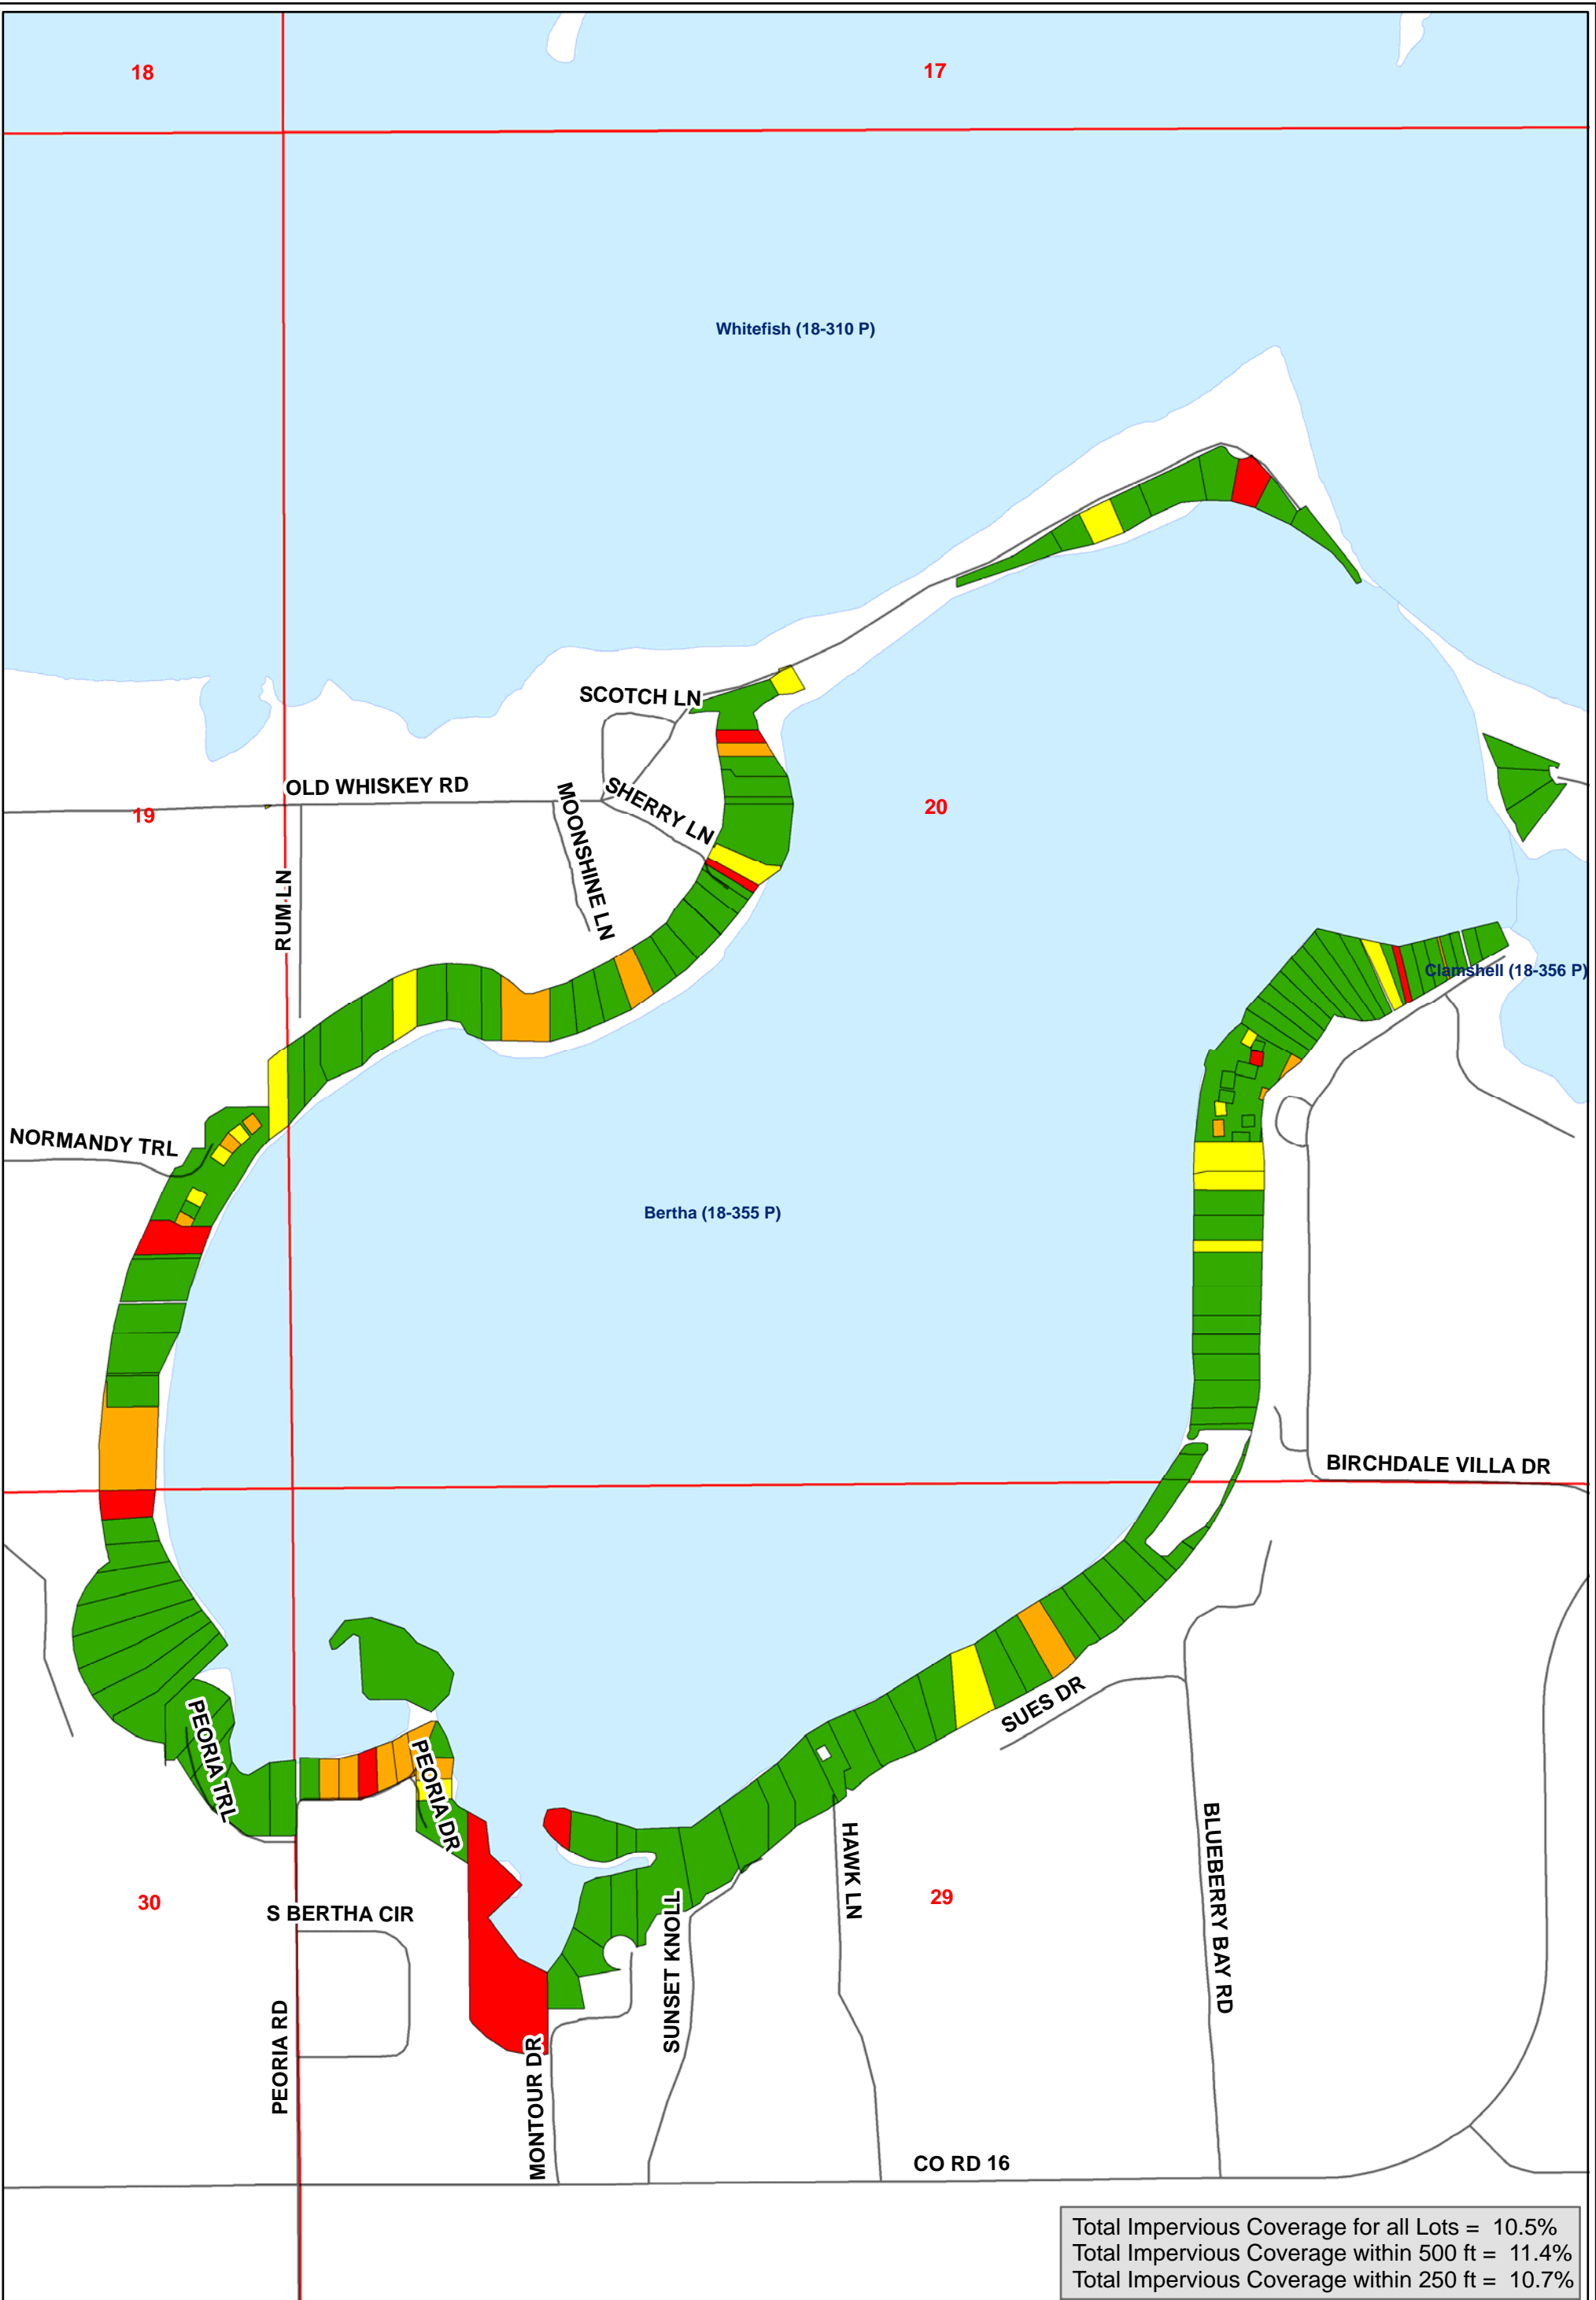
Impervious % within 250 ft of Shoreline

Total Impervious Coverage for all Lots = 10.5%
 Total Impervious Coverage within 500 ft = 11.4%
 Total Impervious Coverage within 250 ft = 10.7%
